Construction, Maintenance, and Monitoring of a Geo-timbergrid Structure

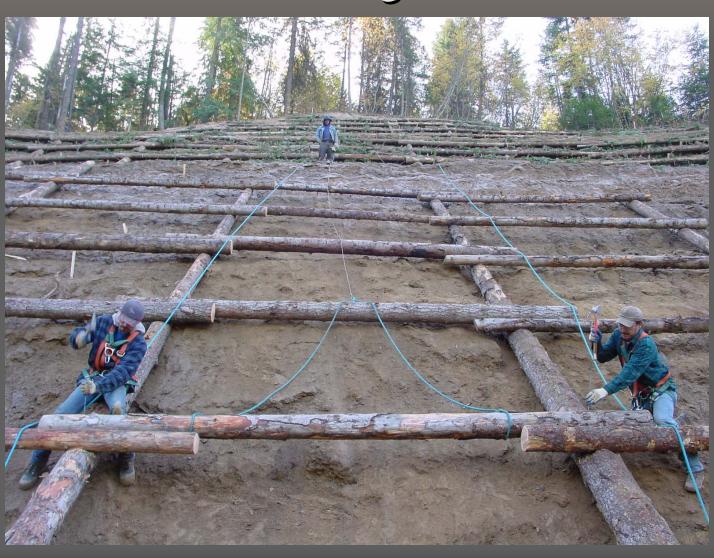
Original Headwall

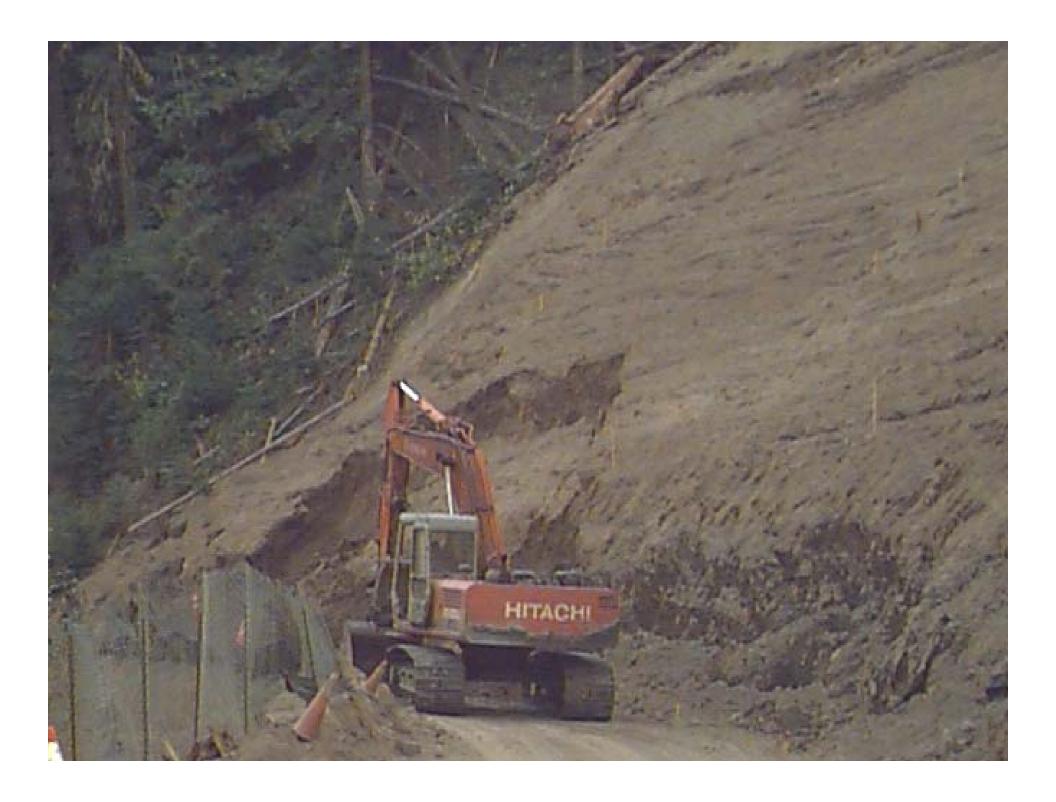
Slopework completed Two benches separating 3, (80%) slopes Gabion toe-support
